Coastal Engineering Technical Note

REVETMENT FAILURE - AN AUSTRALIAN LESSON

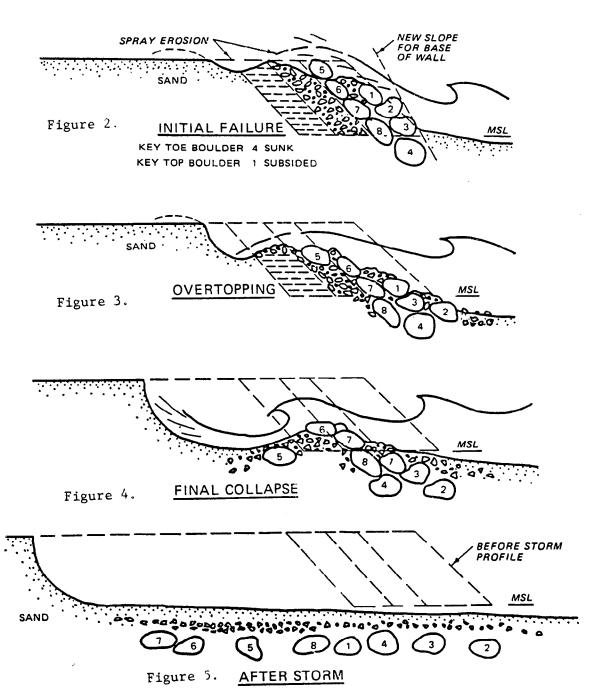
As reported by Smith and Chapman (1982), the initial failure was always triggered by subsidence of the toe units, thus causing the first armor layer to rattle down the slope (see Figure 2). As the freeboard is reduced, waves overtop the revetment and erode the filter material (see Figure 3). Finally, the wall collapses landward into the eroded space (Figure 4) and is buried beneath the beach profile (Figure 5). The observed failure sequence occurs in less than 20 minutes for revetments over 5 m (16 ft) high.

TOP AND TOF PROTECTIONS: It was observed that the stability of top and toe units are critical to overall structural integrity. Dislocation of these armor units would result in structure failure. The initiation of toe failure is always followed by "beach fluidization" at toe area when the wave trough passes there. Large toe units, particularly with low specific surface, easily sink into the fluidized beach. It is recommended that proper design should be accomplished by extending the toe units deep into a stable layer inside the beach profile. The design guidance for rubble toe protection, provided in EM 1110-2-1614 (U.S. Army Corps of Engineers, 1985) and in Chapter 7 of the SPM (1984), should be followed to minimize the chance of toe failure.

The top armor unit has no gravity surcharge and has the least interlocking with its neighboring units. Therefore, it is the unit most susceptible to wave uprush and backwash actions. Dislocation of the top units could result in back erosion which further lead to toe scouring. Smith and Chapman (1982) recommend the use of the largest high aspect armor units laid flat at the top of the revetment with their smallest face exposed seaward.
